**Flood Control Project Maintenance
Levee Inspections
LMA District Cover Sheet
Spring 2012 Levee Inspection Results**

Reclamation District No. 0003 Grand Island

Spring 2012 Levee Inspection Results

Waterway	Bank	Unit Miles
Unit No. 01 Left Bank Steamboat Slough	Left	11.03

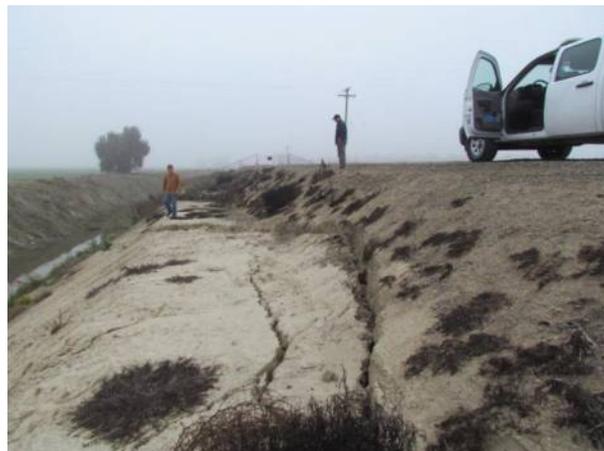
Levee Mile Report Line	9
Start Levee Mile	0.92
End Levee Mile	0.97
Location	Water Side
Category	Supplemental
Item	USACE Erosion Survey
USACE 2011 Photo #2	
richard_s_20120313_142.jpg

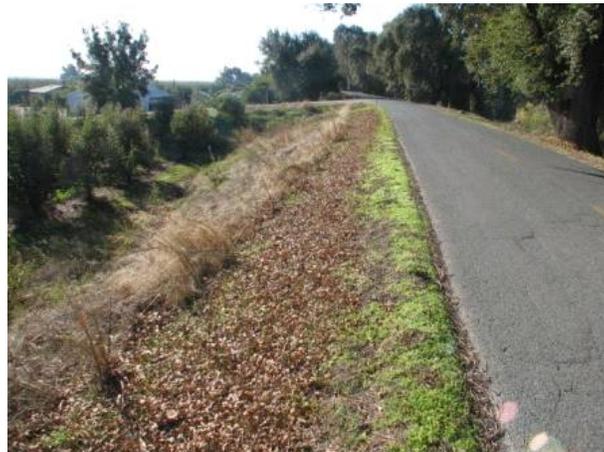
Levee Mile Report Line	12
Start Levee Mile	1.01
End Levee Mile	1.03
Location	Land Side
Category	Earthen Levee
Item	Vegetation
Grass on levee slope and toe exceeds 12" and partially obstructs visibility.	
richard_s_20120313_162.jpg

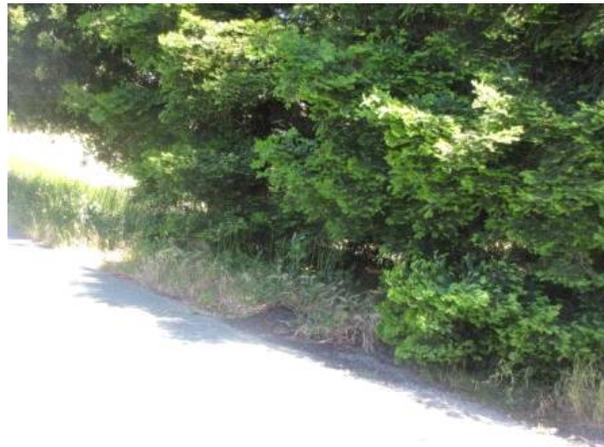
Levee Mile Report Line	17
Start Levee Mile	1.60
End Levee Mile	1.60
Location	Land Side
Category	Earthen Levee
Item	Vegetation
Looking southeast at dense trees on landside shoulder and slope.	
richard_s_20120313_149.jpg

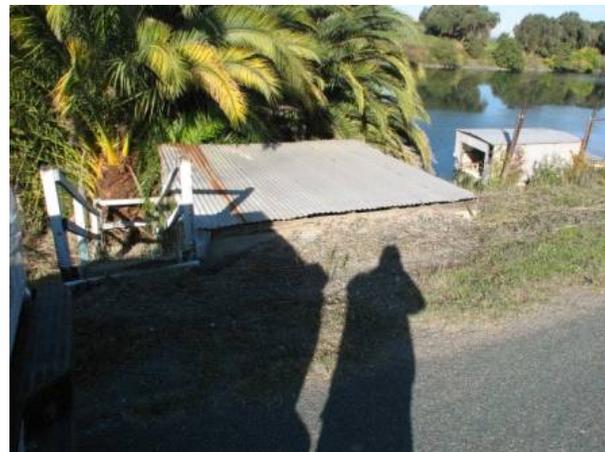
Levee Mile Report Line	25
Start Levee Mile	2.07
End Levee Mile	2.07
Location	Water Side
Category	Earthen Levee
Item	Encroachments
Pipe penetration and pump shed on waterside slope.	
richard_s_20120313_166.jpg

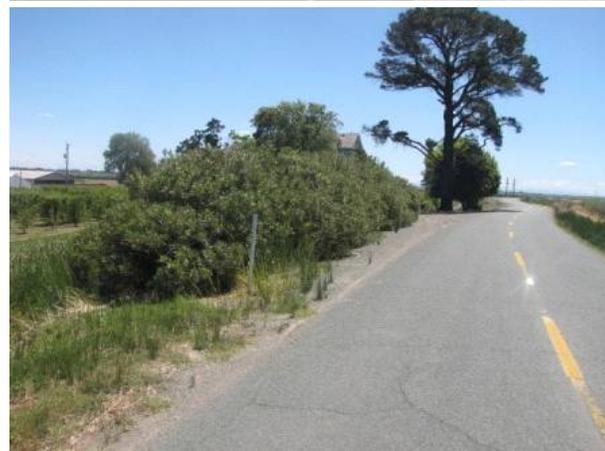
Levee Mile Report Line	31
Start Levee Mile	3.13
End Levee Mile	3.15
Location	Land Side
Category	Earthen Levee
Item	Vegetation
Looking northeast at dense veg. on landside slope.	
richard_s_20120313_151.jpg

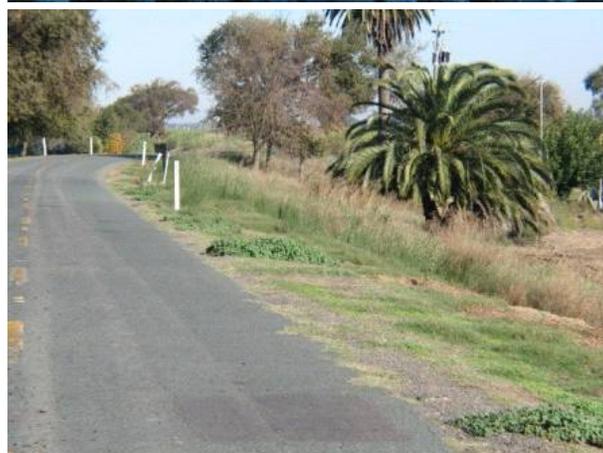
Levee Mile Report Line	43
Start Levee Mile	4.30
End Levee Mile	4.49
Location	Land Side
Category	Earthen Levee
Item	Vegetation
Vegetation on levee slopes and toe partially obstruct visibility.	
richard_s_20120313_169.jpg

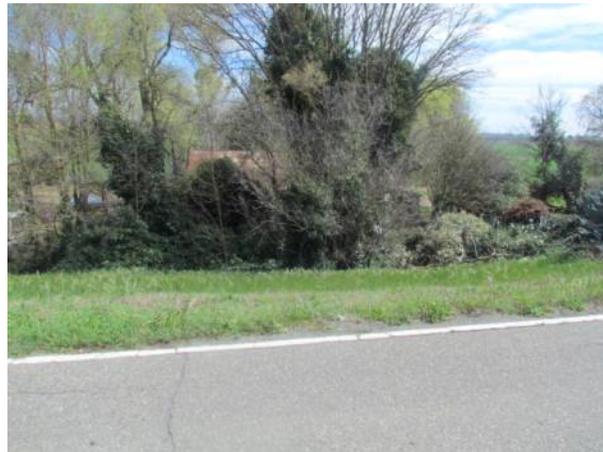
Levee Mile Report Line	49
Start Levee Mile	5.53
End Levee Mile	5.53
Location	Land Side
Category	Earthen Levee
Item	Vegetation
Looking east at landscaping on landside toe.	
richard_s_20120328_190.jpg

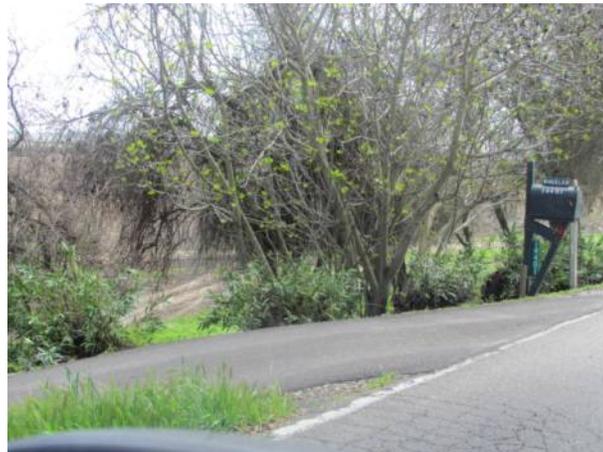
Levee Mile Report Line	52
Start Levee Mile	5.76
End Levee Mile	5.76
Location	Land Side
Category	Earthen Levee
Item	Vegetation
Looking southeast at trimmed landscaping on landside shoulder and slope. (Updated Spring 2012)	
richard_s_20120328_191.jpg

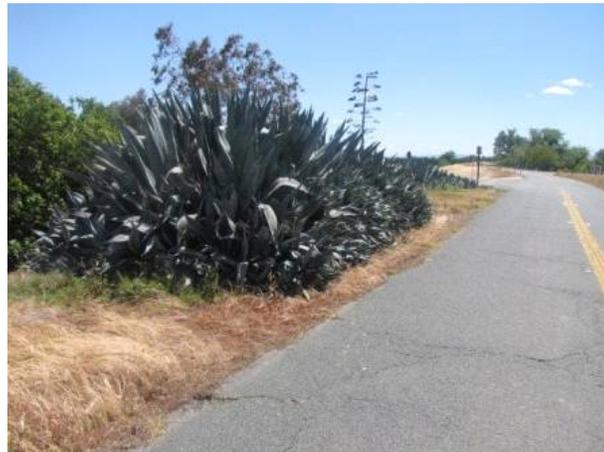
Levee Mile Report Line	59
Start Levee Mile	7.08
End Levee Mile	7.10
Location	Land Side
Category	Earthen Levee
Item	Vegetation
Looking northeast at updated picture (5/2010) century plant on landside shoulder and slope.	
richard_s_20120313_156.jpg

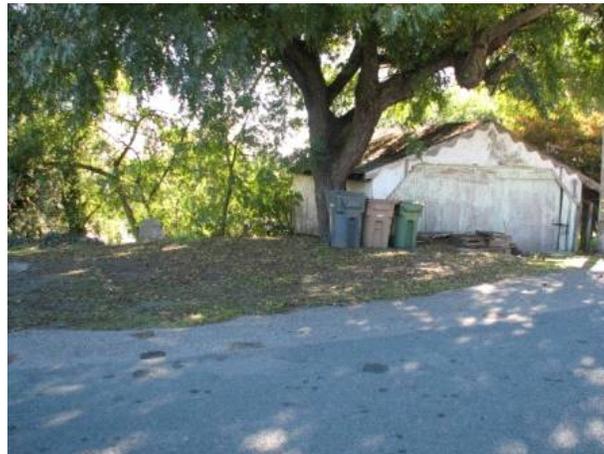
Levee Mile Report Line	63
Start Levee Mile	7.69
End Levee Mile	7.69
Location	Land Side
Category	Earthen Levee
Item	Encroachments
Buildings obstruct access and visibility of levee slope and toe.	
richard_s_20120313_175.jpg

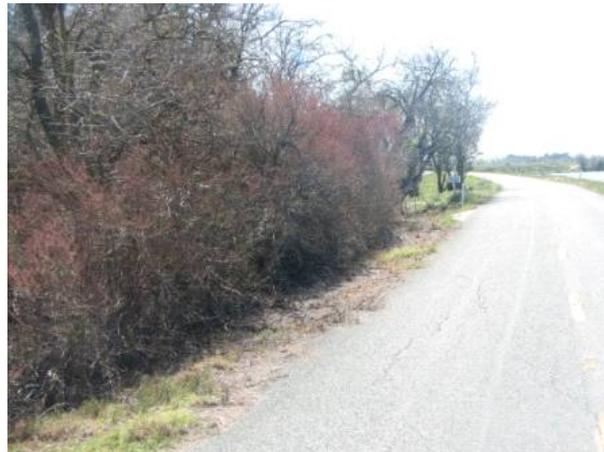
Levee Mile Report Line	83
Start Levee Mile	10.20
End Levee Mile	10.22
Location	Land Side
Category	Earthen Levee
Item	Trim / Thin Trees
Trees to be trimmed on landside shoulder from LM 10.20 to 10.22	
richard_s_20120313_158.jpg

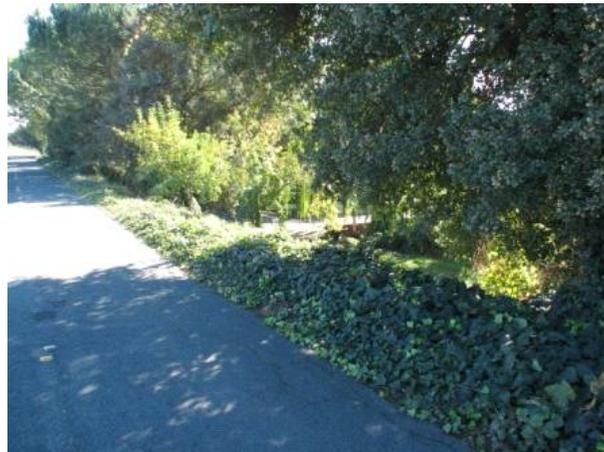
Levee Mile Report Line	8
Start Levee Mile	1.93
End Levee Mile	1.98
Location	Water Side
Category	Earthen Levee
Item	Vegetation
Landscaping on levee slope obstructs visibility and access.	
richard_s_20120313_370.jpg

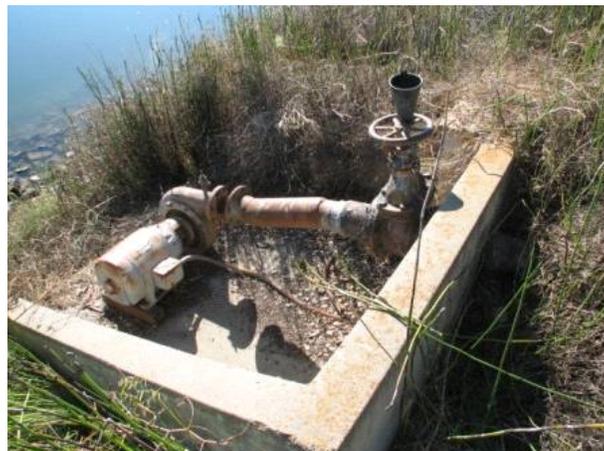
Levee Mile Report Line	15
Start Levee Mile	3.39
End Levee Mile	3.39
Location	Water Side
Category	Earthen Levee
Item	Encroachments
Pipe penetration closure valve in open position.	
richard_s_20120313_364.jpg

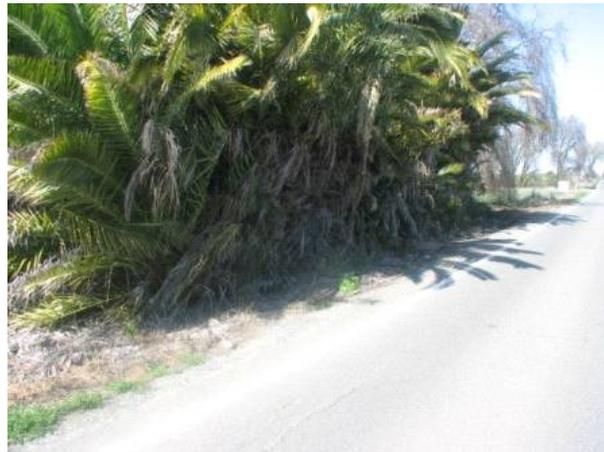
Levee Mile Report Line	34
Start Levee Mile	7.02
End Levee Mile	7.04
Location	Land Side
Category	Earthen Levee
Item	Trim / Thin Trees
Front view of palm trees on landside shoulder	
richard_s_20120313_354.jpg

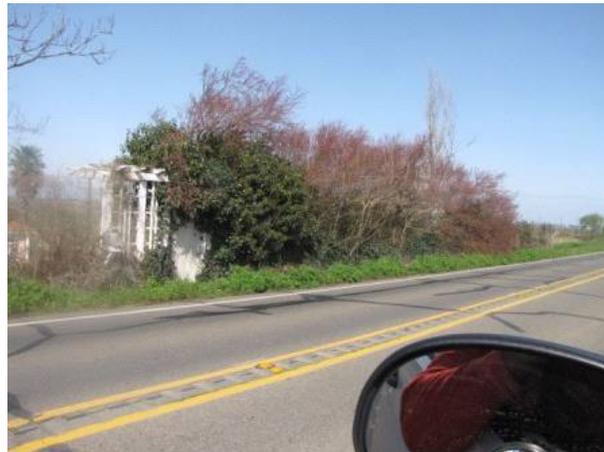
Levee Mile Report Line	36
Start Levee Mile	7.38
End Levee Mile	7.38
Location	Land Side
Category	Earthen Levee
Item	Vegetation
Looking northwest a dense landscaping on landside shoulder and slope.	
richard_s_20120313_365.jpg

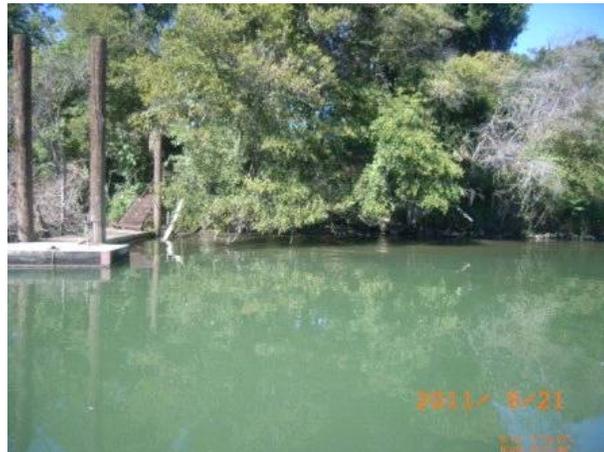
Levee Mile Report Line	58
Start Levee Mile	11.52
End Levee Mile	11.52
Location	Water Side
Category	Supplemental
Item	USACE Erosion Survey
USACE 2011 Photo #1	
richard_s_20120313_360.jpg
